Ecological Restoration at The Mill Swamp Mitigation Bank

60% Project Design - Public Meeting held at Charles County Public Library – Potomac Branch
MDE Tracking No.: 22-NT-0001/202261353

December 10, 2025

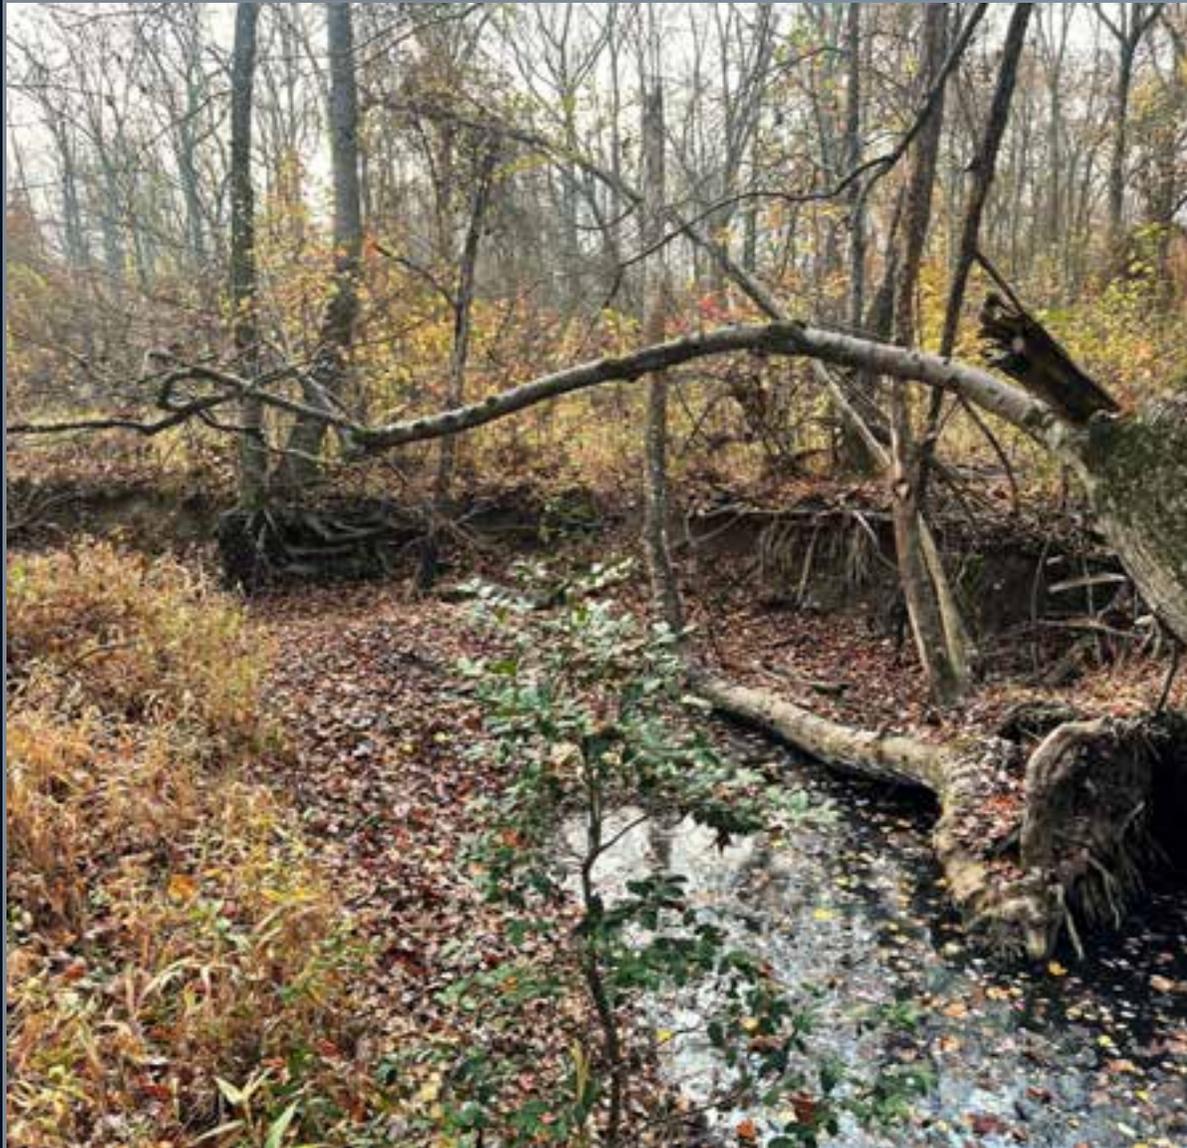
Stream is disconnected from the floodplain. Stream banks are actively eroding.

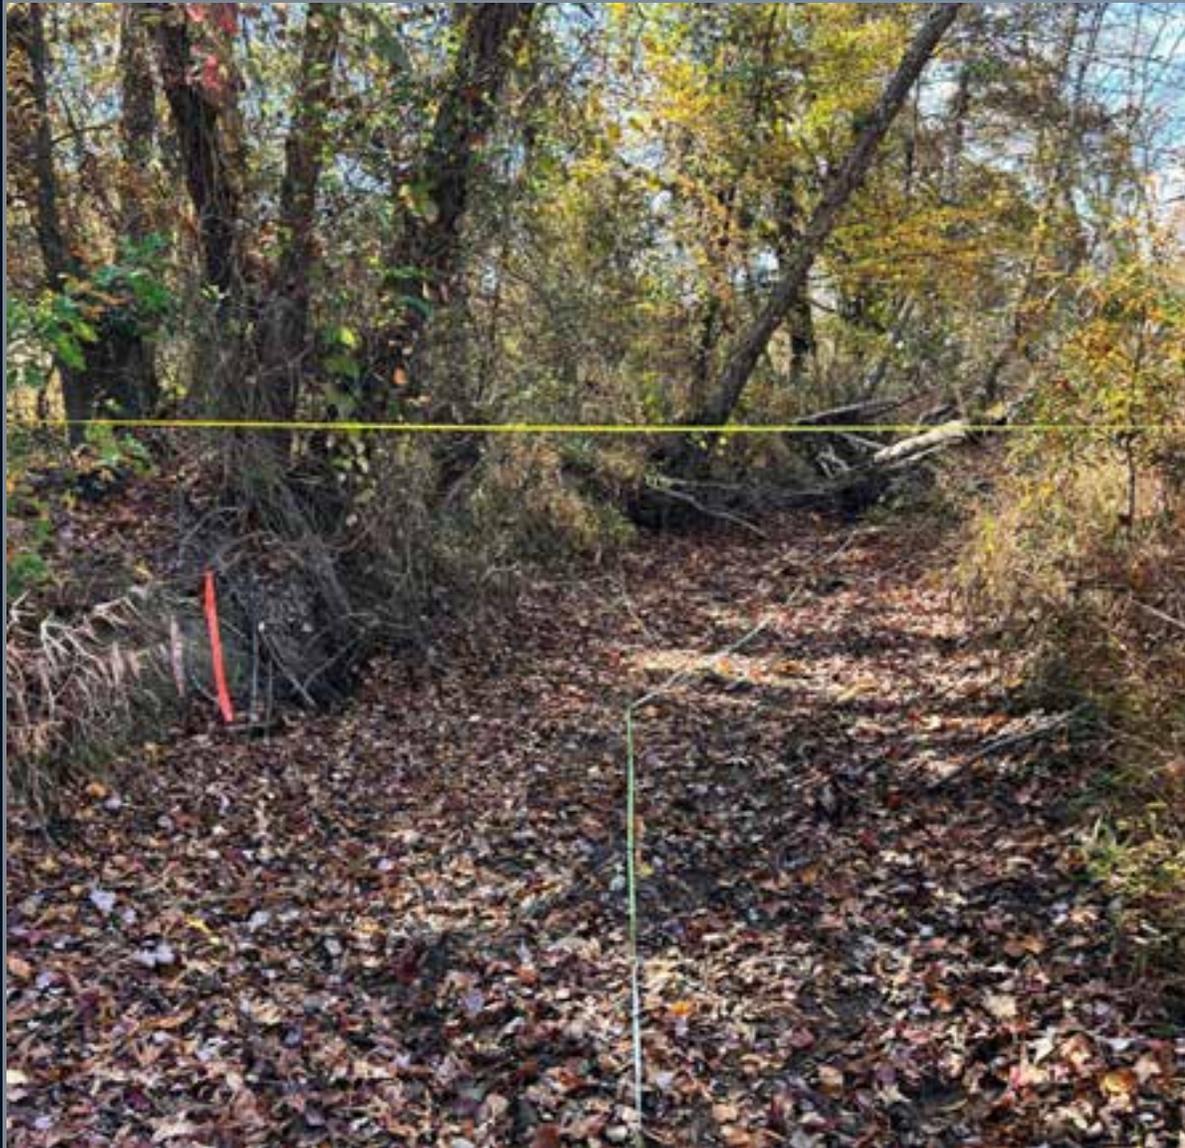
Stream Channel Geomorphic Assessment

- Historical Records Search
 - Historic agriculture operation altered natural stream pattern
 - Widespread Deforestation
- Geomorphic Analysis of Stream
 - Straightening of stream channel has led to increased flows
 - Disconnection from the floodplain & adjacent wetlands
 - Exposed stream banks facilitate erosion
- Forest Stand Delineation
 - Forest health, successional stage, species diversity & abundance, canopy coverage, habitat, environmental features & functions

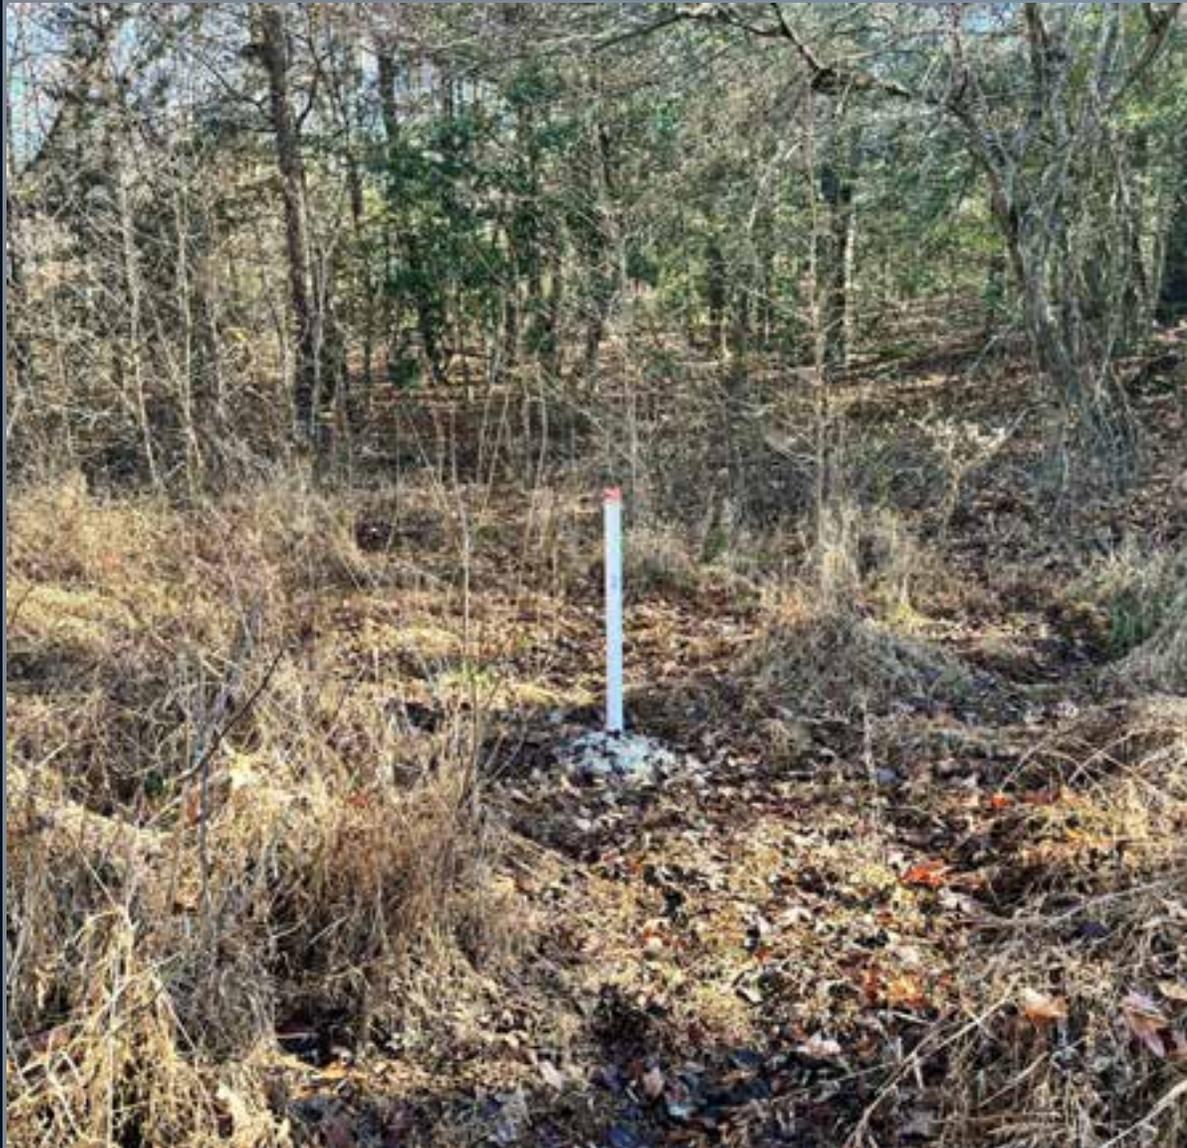
Groundwater Well

- Wetland Delineation
 - Groundwater Sensors / Wells
- Invasive Species Mapping
- Habitat Assessment
 - Minimal available suitable in-stream habitat
- Benthic Survey
- Fish Survey
- In-stream Temperature Monitoring
 - Continuously collecting data since 2021

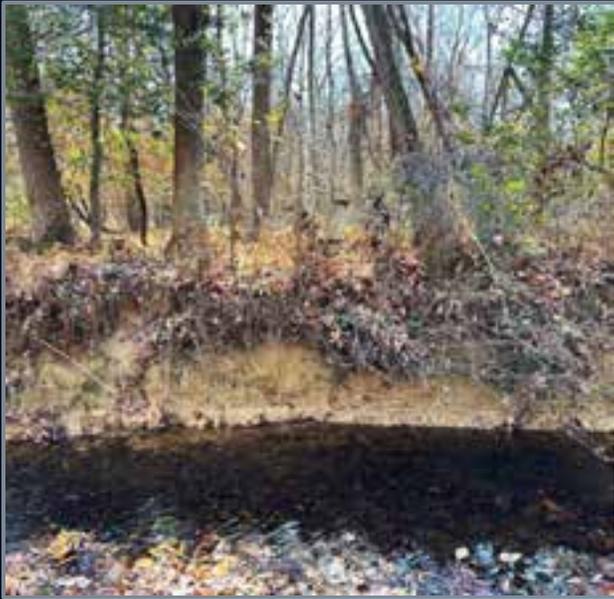
*Stream disconnected from floodplain,
streambank erosion*

- Erosion
 - Destroys habitat
 - Loss of land takes plants and trees with it
 - Degrades water quality
 - Sediment falls into the stream
 - Loss of land
 - Stream expands laterally and deepens vertically
- Stream Disconnected from Floodplain
 - Caused by erosion
 - Stream cannot access floodplain to spread out water during a storm event
 - Water stays trapped in the stream channel, so the water level rises higher
 - Increases the chances of flooding nearby roads and properties.
- Degraded habitat
 - Floodplain animals lose their home when stream is disconnected
 - Fish and other creatures cannot survive in muddy water
 - Fewer species and less diversity

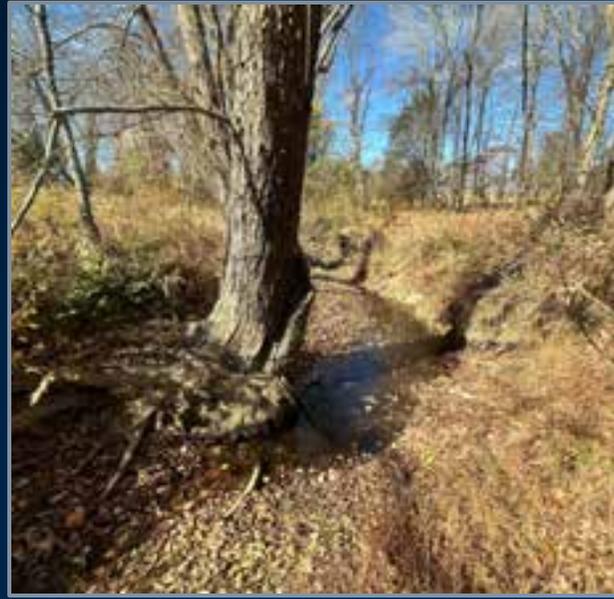
Stream soil eroding around tree roots

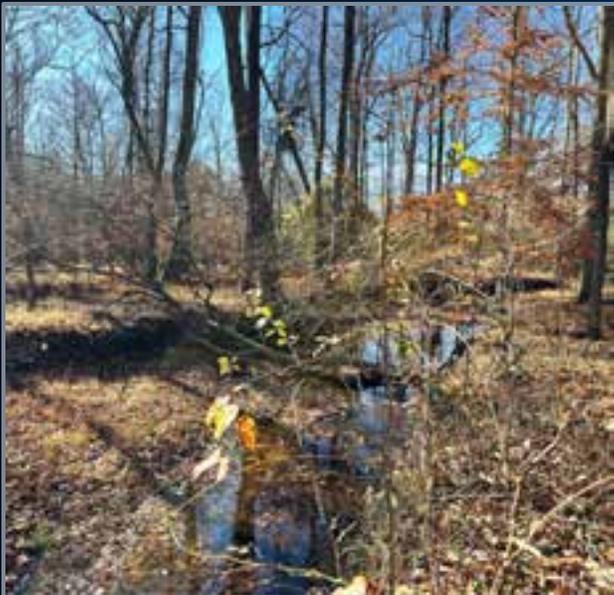
*Trees falling into channel due to streambank
erosion.*

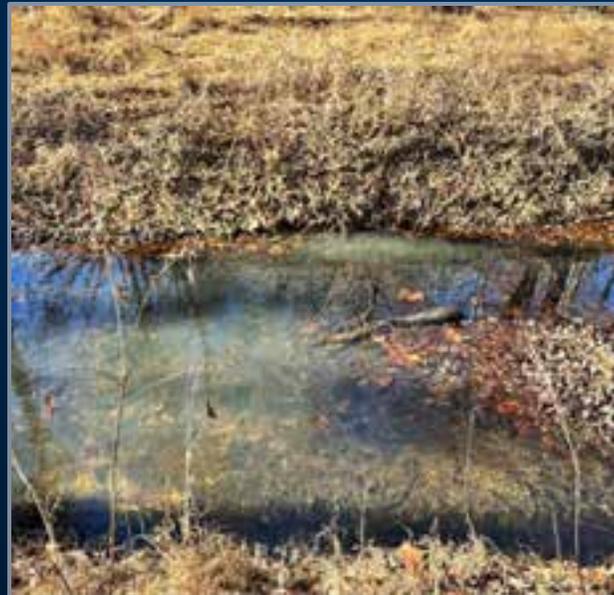
Cloudy water decreases available habitat

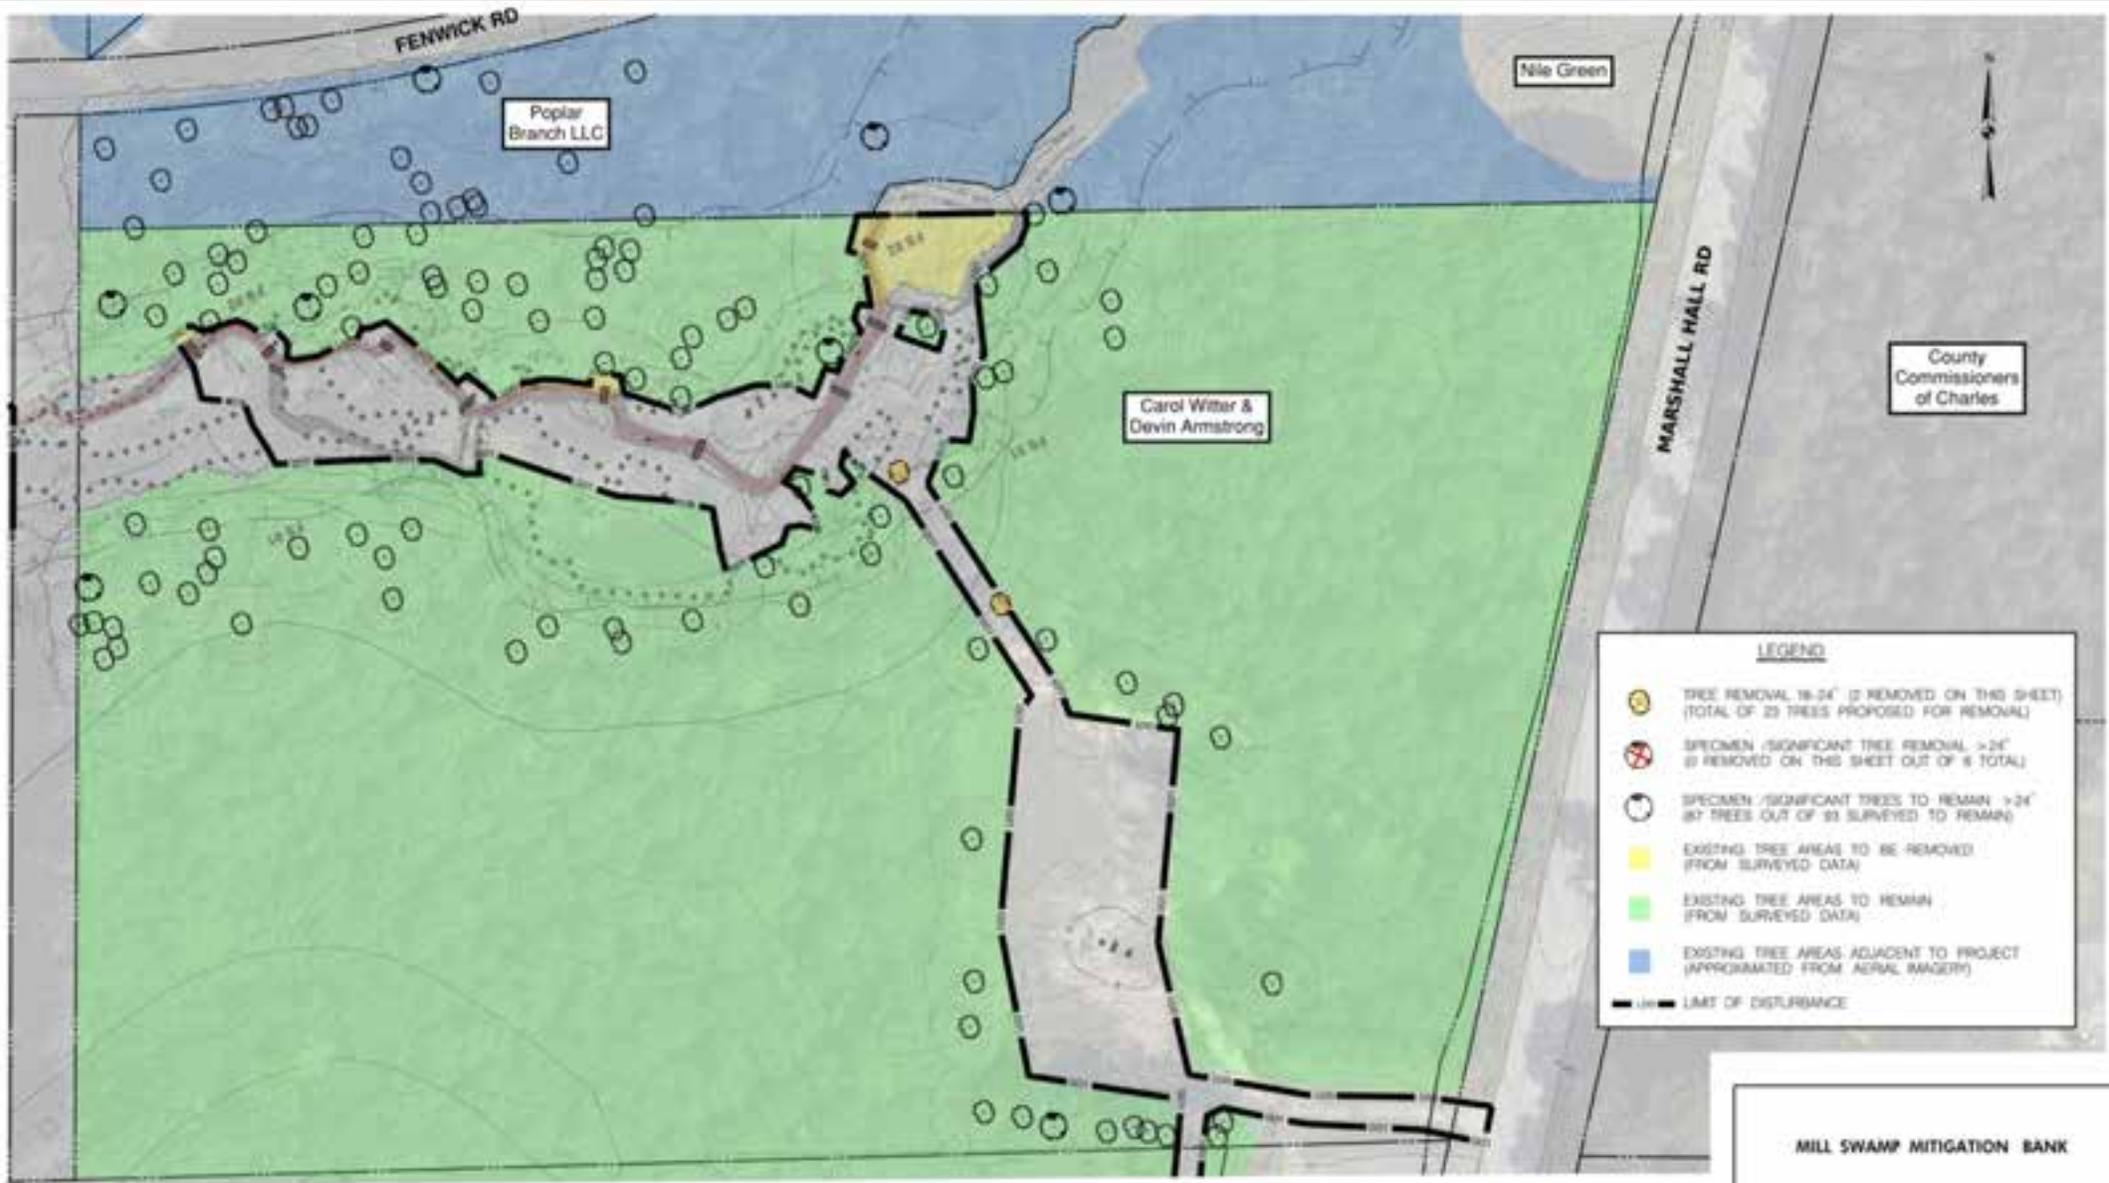
TREES SITE PLAN		
DATE: 01/20/2023	DATE: 01/20/2023	DATE: 01/20/2023
DESIGNED BY: JMT	CHECKED BY: JMT	APPROVED BY: JMT
DRAWN BY: JMT	DATE: 01/20/2023	SCALE: 1" = 50'
PROJECT NO: TSP-01	SHEET NO: 3	TOTAL SHEETS: 3

- Existing forests
 - Restoration requires minimum forest impacts
 - Proposed design protects in perpetuity many high-quality trees
 - Unavoidable impacts to forest will be replaced and new forested areas will be created

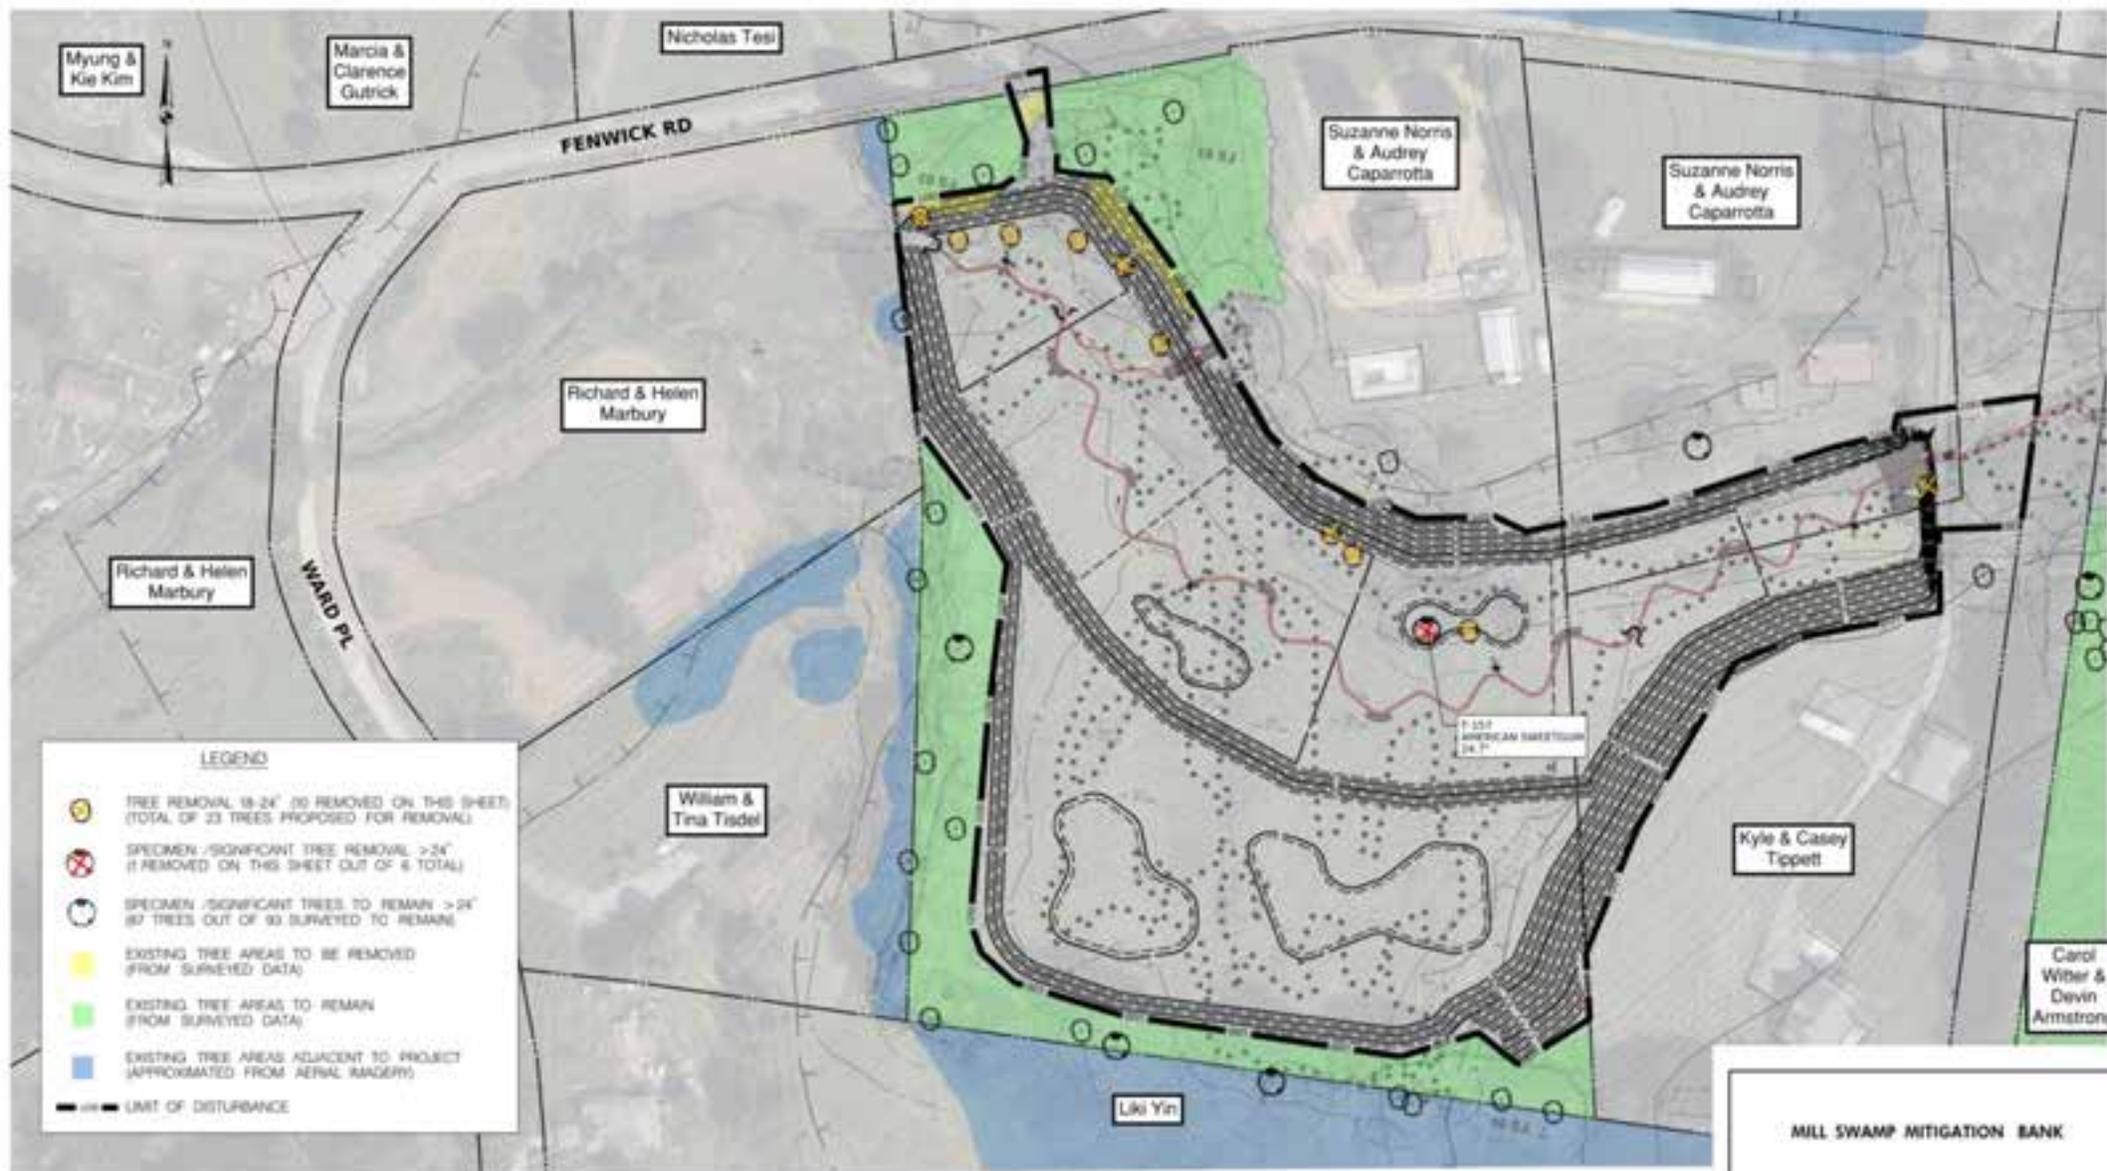
- LEGEND**
- TREE REMOVAL 18-24" (6 REMOVED ON THIS SHEET) (TOTAL OF 23 TREES PROPOSED FOR REMOVAL)
 - SPECIMEN /SIGNIFICANT TREE REMOVAL >24" (1 REMOVED ON THIS SHEET OUT OF 6 TOTAL)
 - SPECIMEN /SIGNIFICANT TREES TO REMAIN >24" (67 TREES OUT OF 93 SURVEYED TO REMAIN)
 - EXISTING TREE AREAS TO BE REMOVED (FROM SURVEYED DATA)
 - EXISTING TREE AREAS TO REMAIN (FROM SURVEYED DATA)
 - EXISTING TREE AREAS ADJACENT TO PROJECT (APPROXIMATED FROM AERIAL IMAGERY)
 - LIMIT OF DISTURBANCE

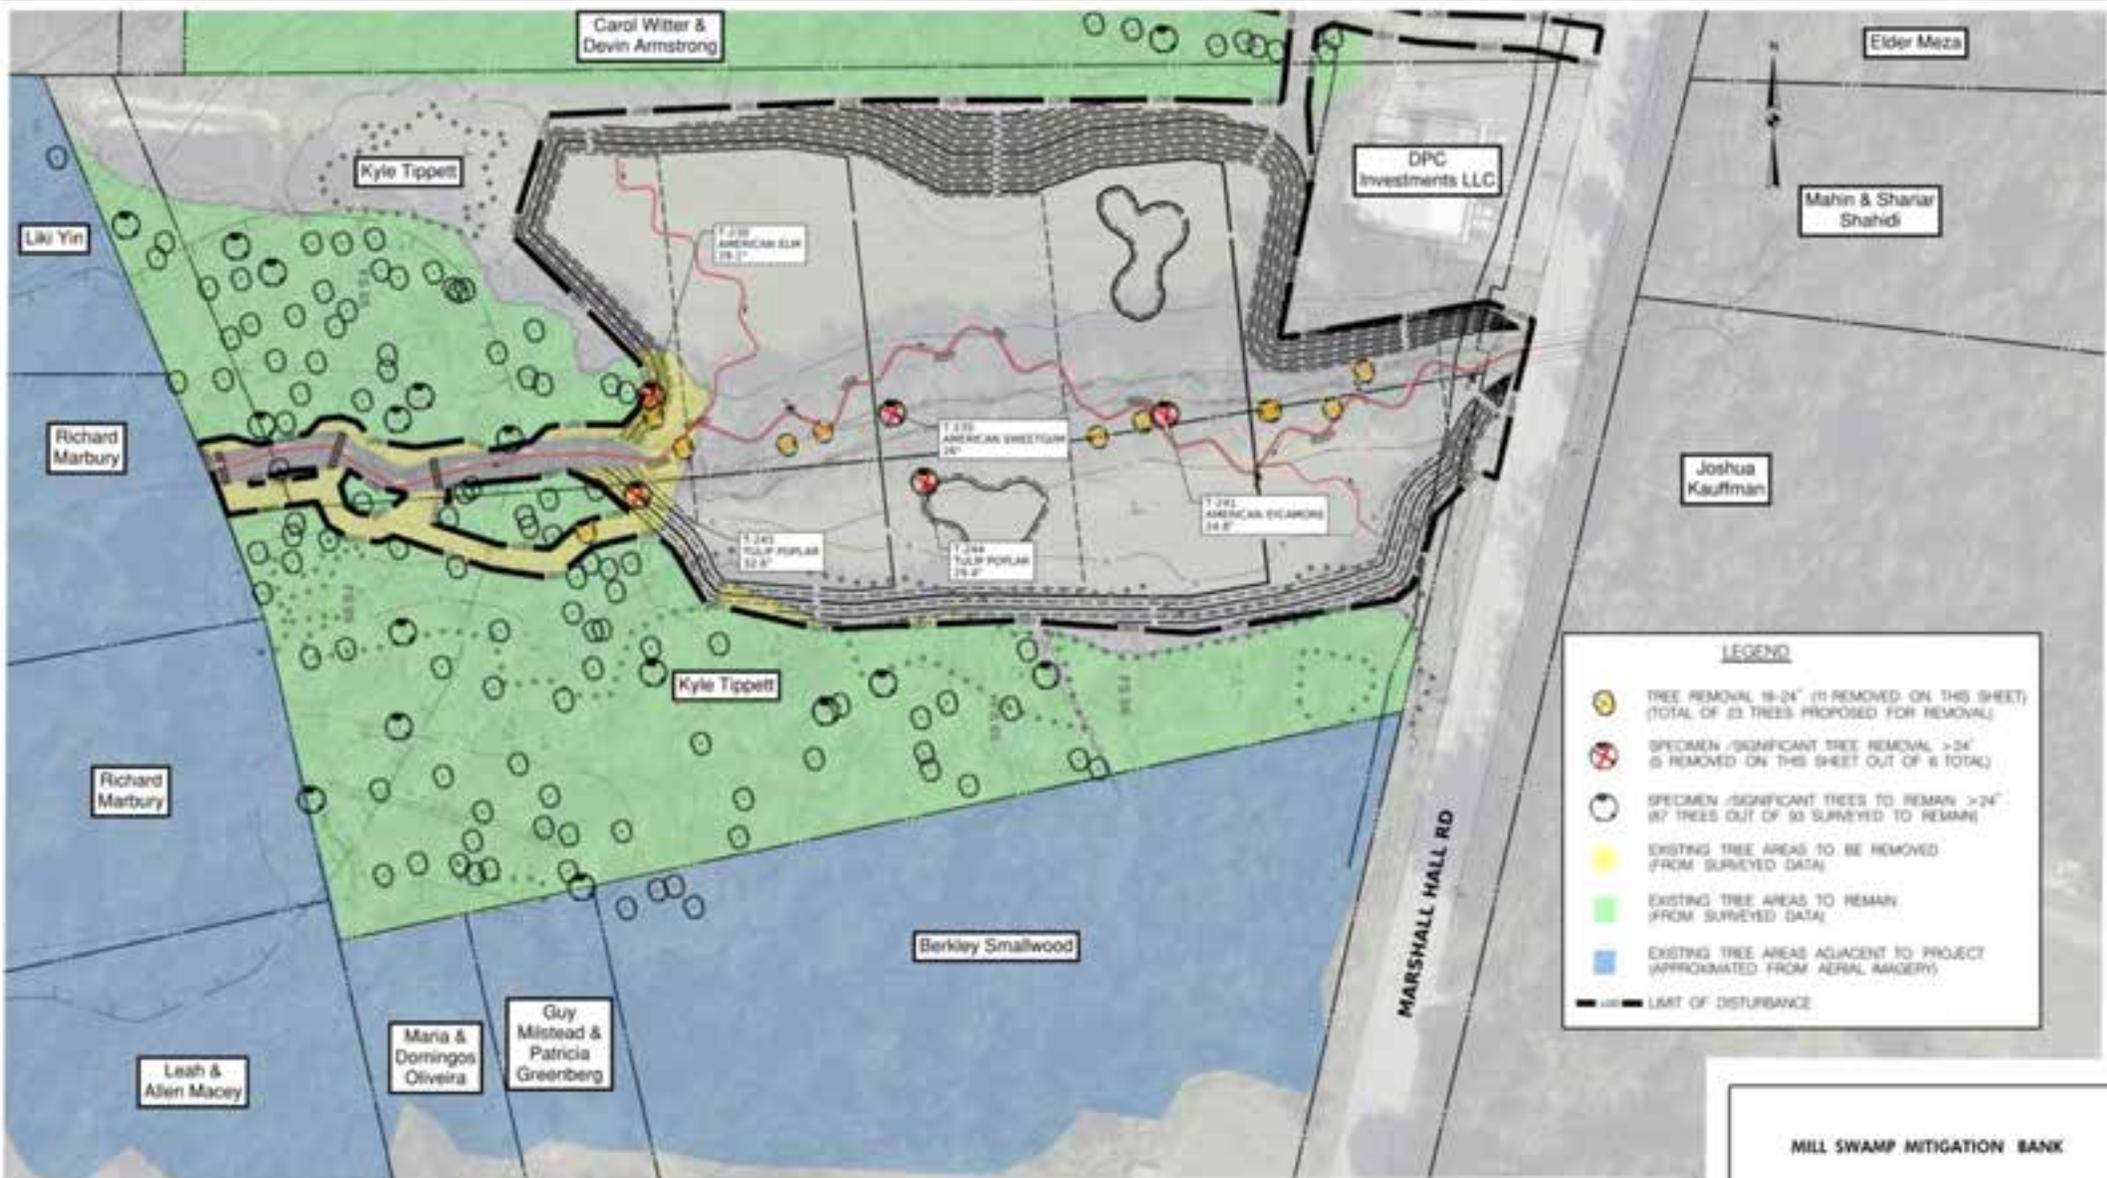
- TREE REMOVAL 18-24" (11 REMOVED ON THIS SHEET) (TOTAL OF 23 TREES PROPOSED FOR REMOVAL)
- SPECIMEN /SIGNIFICANT TREE REMOVAL >24" IS REMOVED ON THIS SHEET OUT OF 8 TOTAL
- SPECIMEN /SIGNIFICANT TREES TO REMAIN >24" (87 TREES OUT OF 93 SURVEYED TO REMAIN)
- EXISTING TREE AREAS TO BE REMOVED (FROM SURVEYED DATA)
- EXISTING TREE AREAS TO REMAIN (FROM SURVEYED DATA)
- EXISTING TREE AREAS ADJACENT TO PROJECT (APPROXIMATED FROM AERIAL IMAGERY)
- LIMIT OF DISTURBANCE

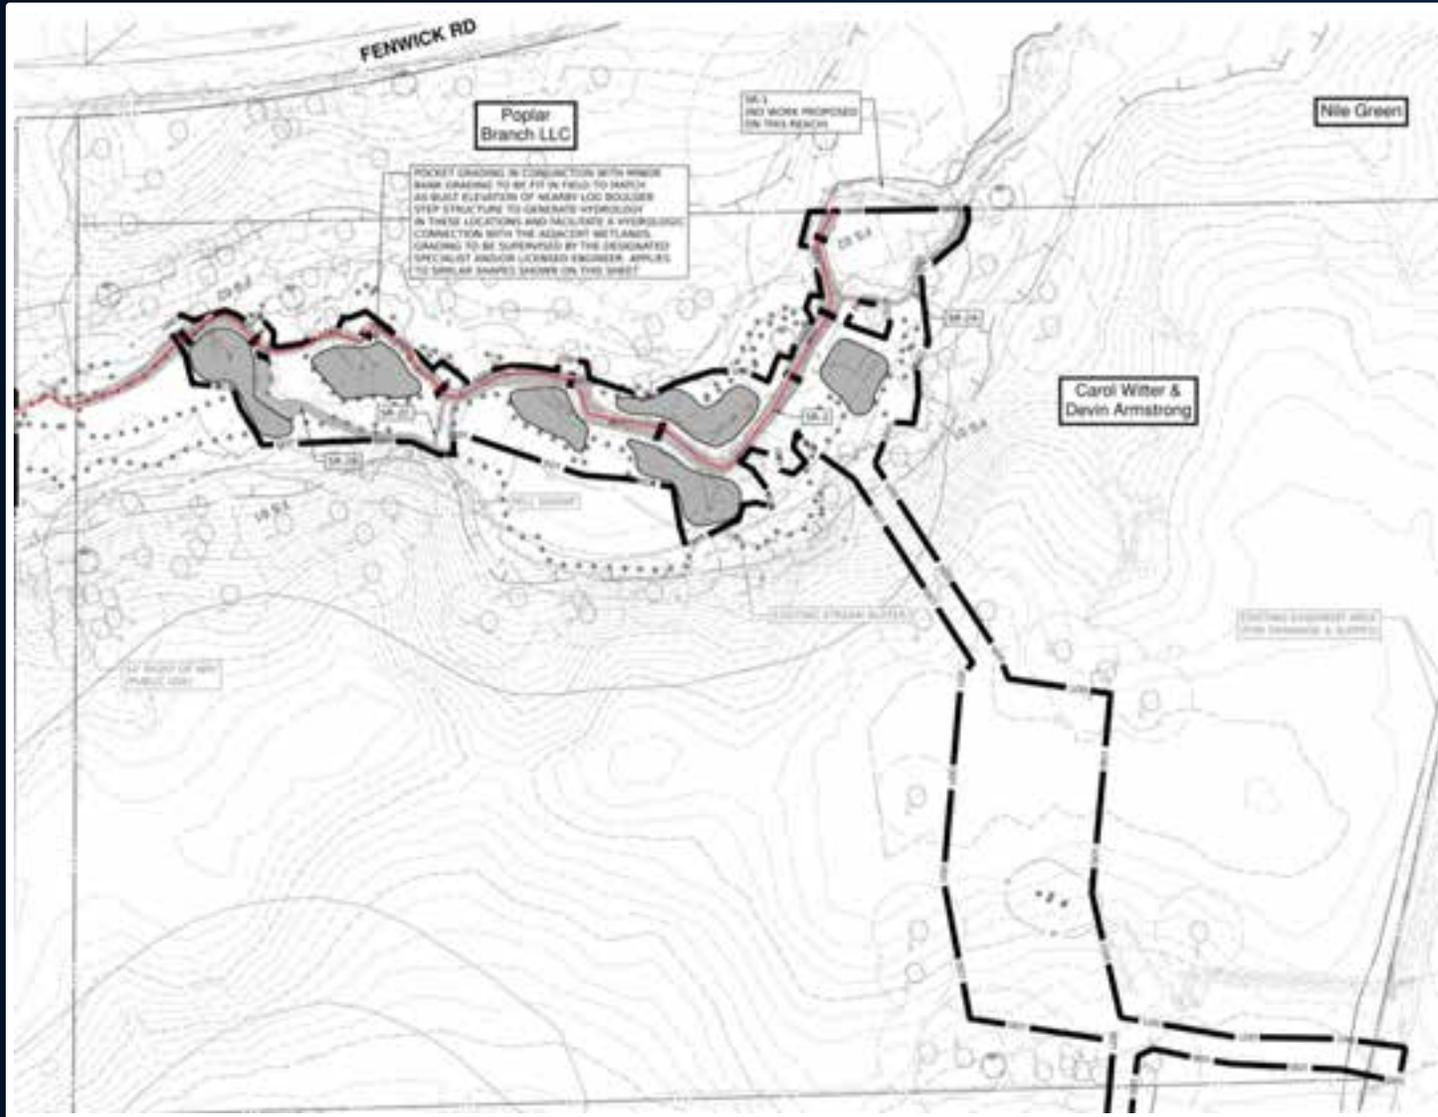
- Avoidance of Trees / Minimization of Tree Removal
- Connect the stream channel to its floodplain and adjacent wetlands
- Plant trees in work area to connect to adjacent forest stands
- Preserve existing high-quality wetlands

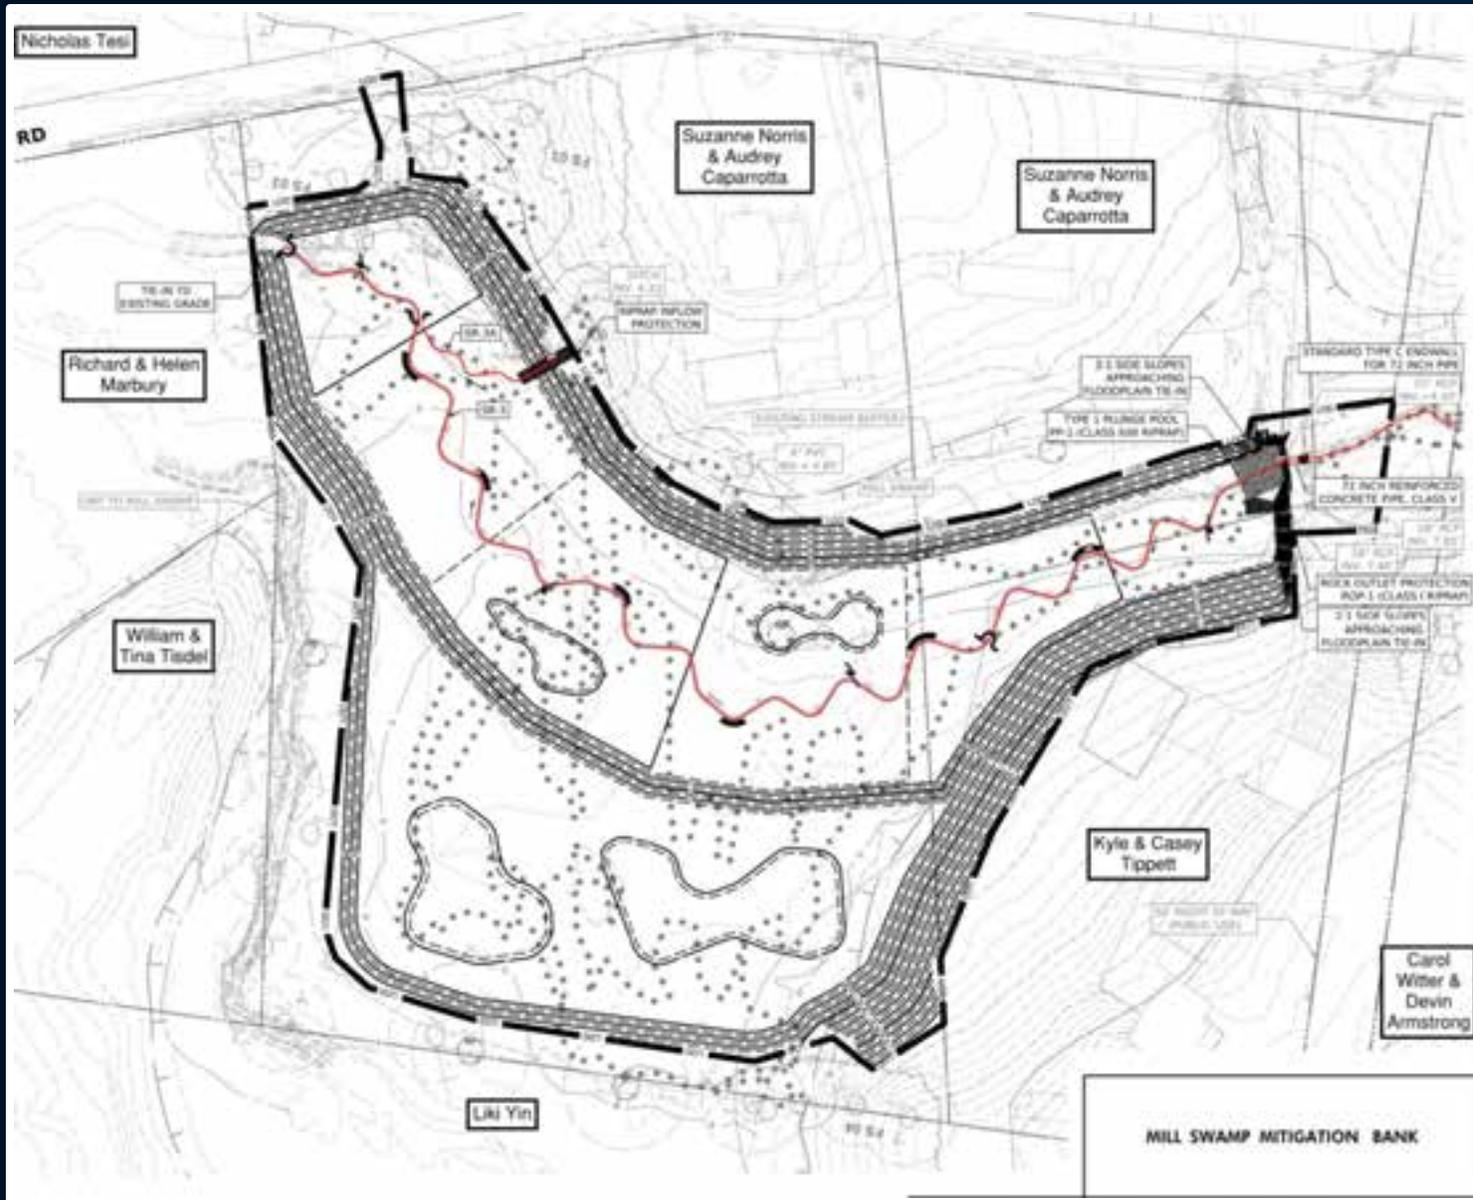
- Avoidance of Trees / Minimization of Tree Removal
- Relocate stream to center of valley
- Restore historic wetlands by connecting the system to groundwater
- Plant trees in work area to connect to adjacent forest stands

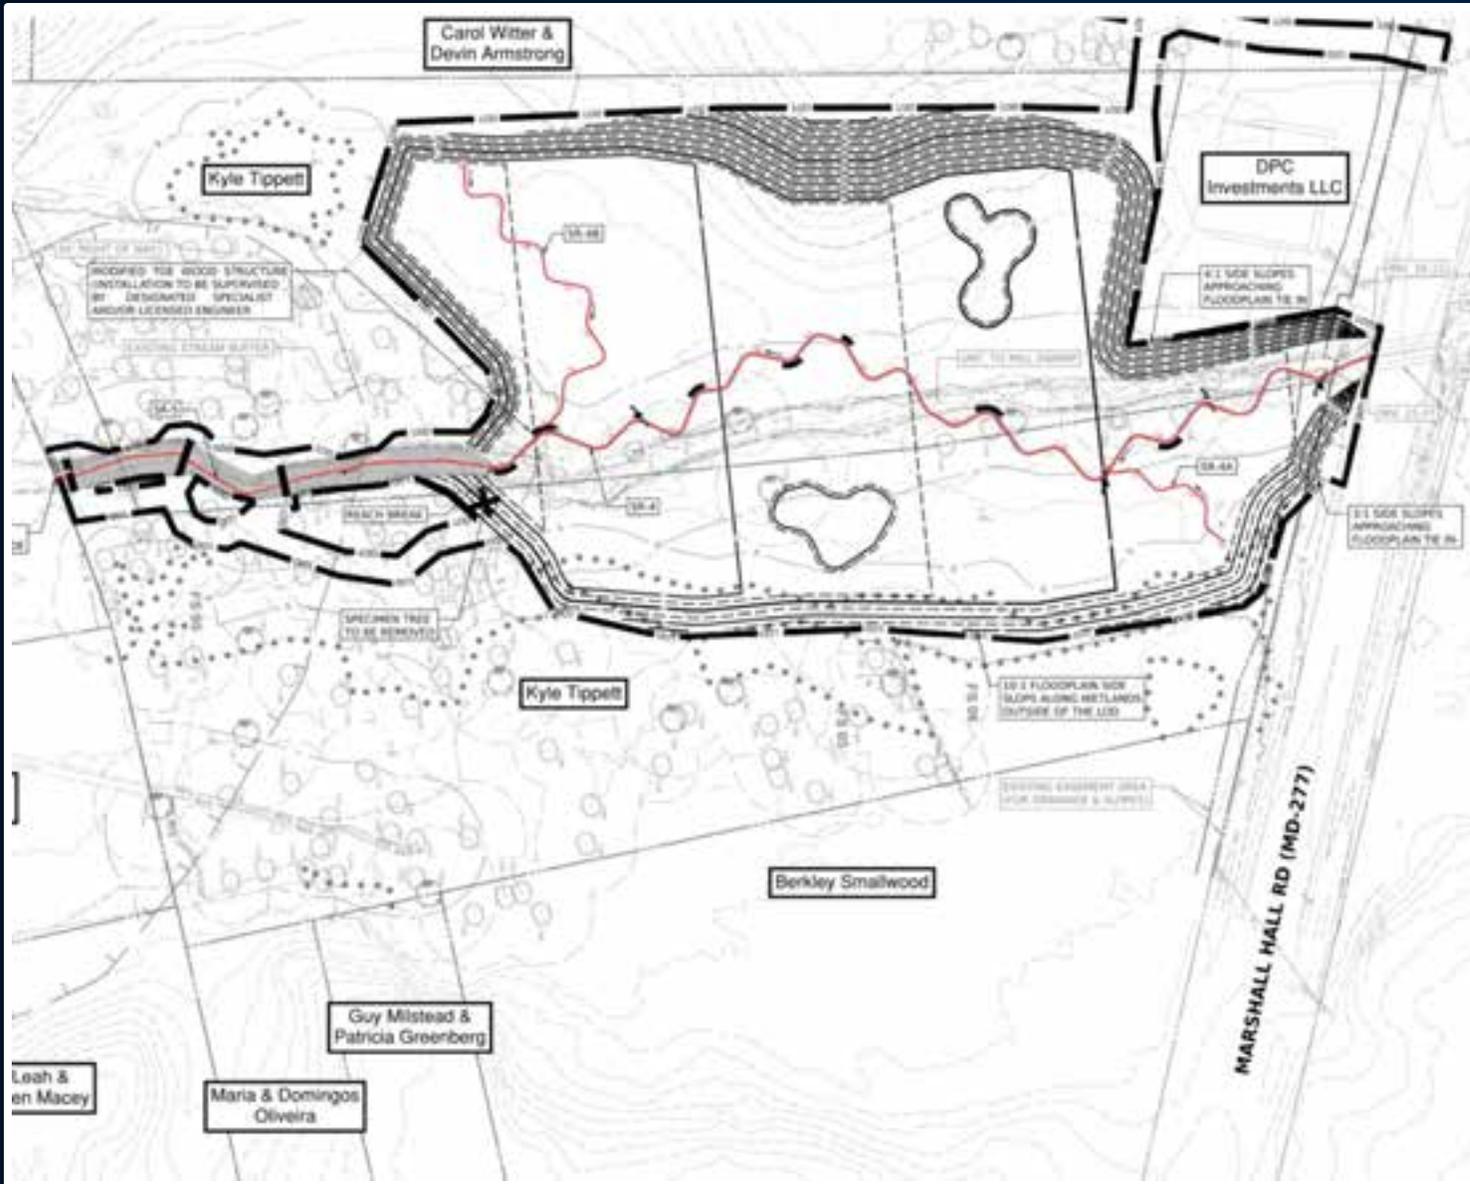
- Avoidance of Trees / Minimization of Tree Removal
- Connect the stream channel to its floodplain and restore historic wetlands
- Plant trees in work areas to connect to adjacent forest stands
- Preserve existing high-quality wetlands

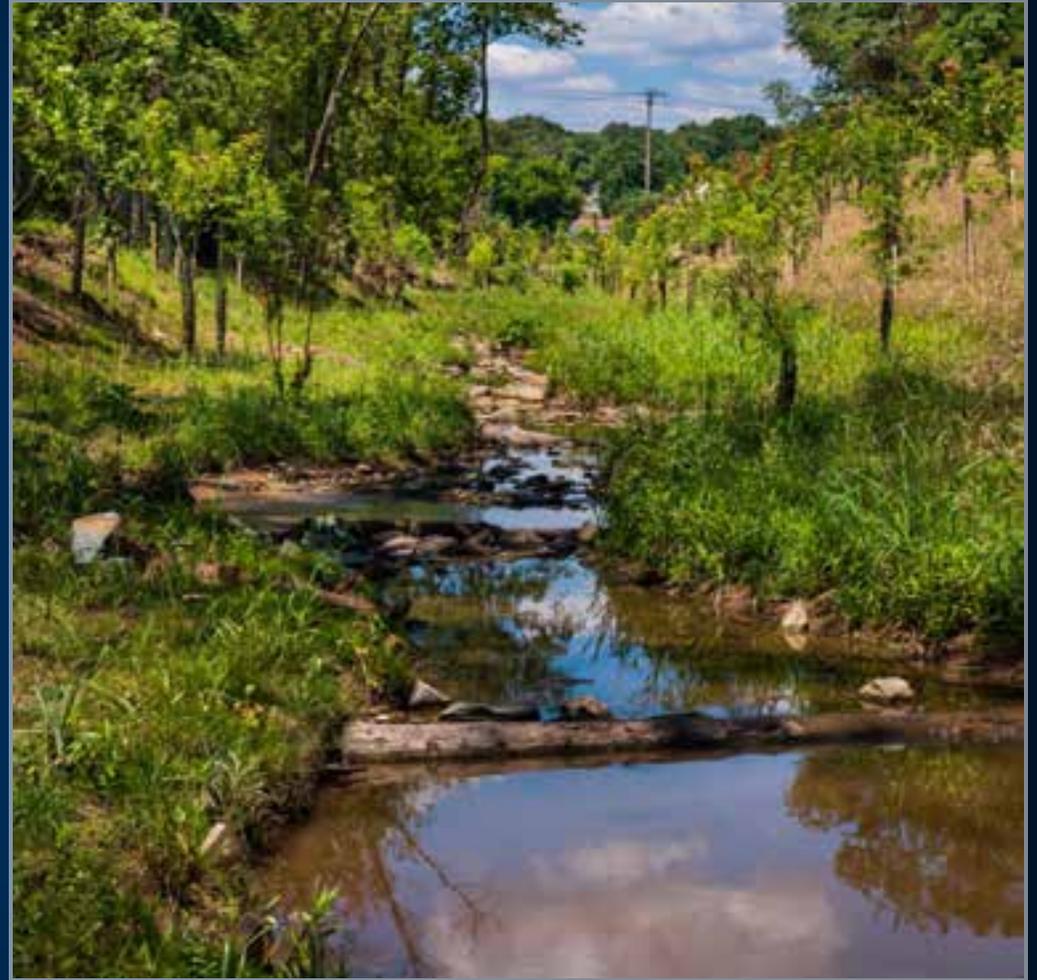
Wood used for in-channel structures
